# Damming a bedrock cut to daylight a buried stream under an abandoned railroad crossing in the Eel River Canyon of northwest California

# Damming a Bedrock Cut to Daylight a Buried Stream

Woodman Creek, Eel River Canyon, NW California

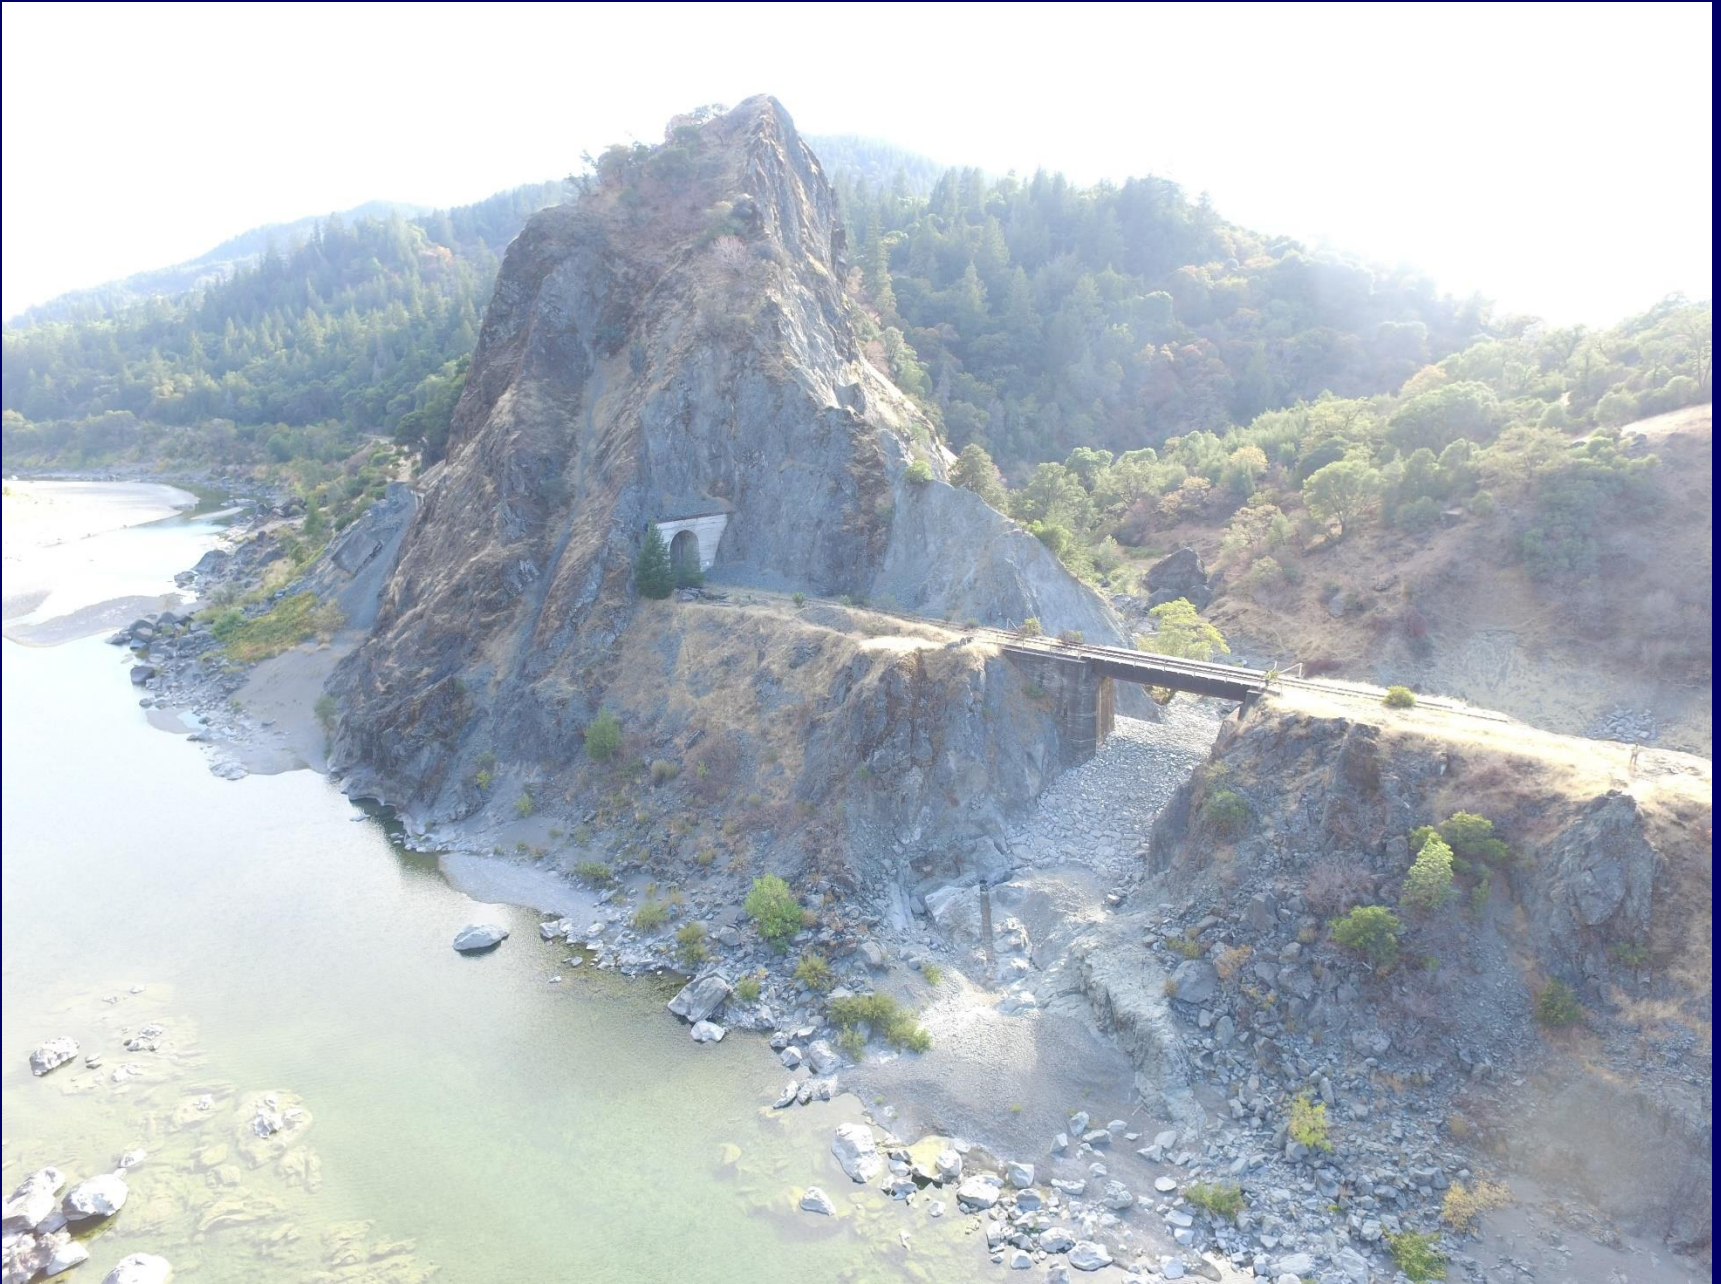
# The “Plugged” Bedrock Cut fom Eel River

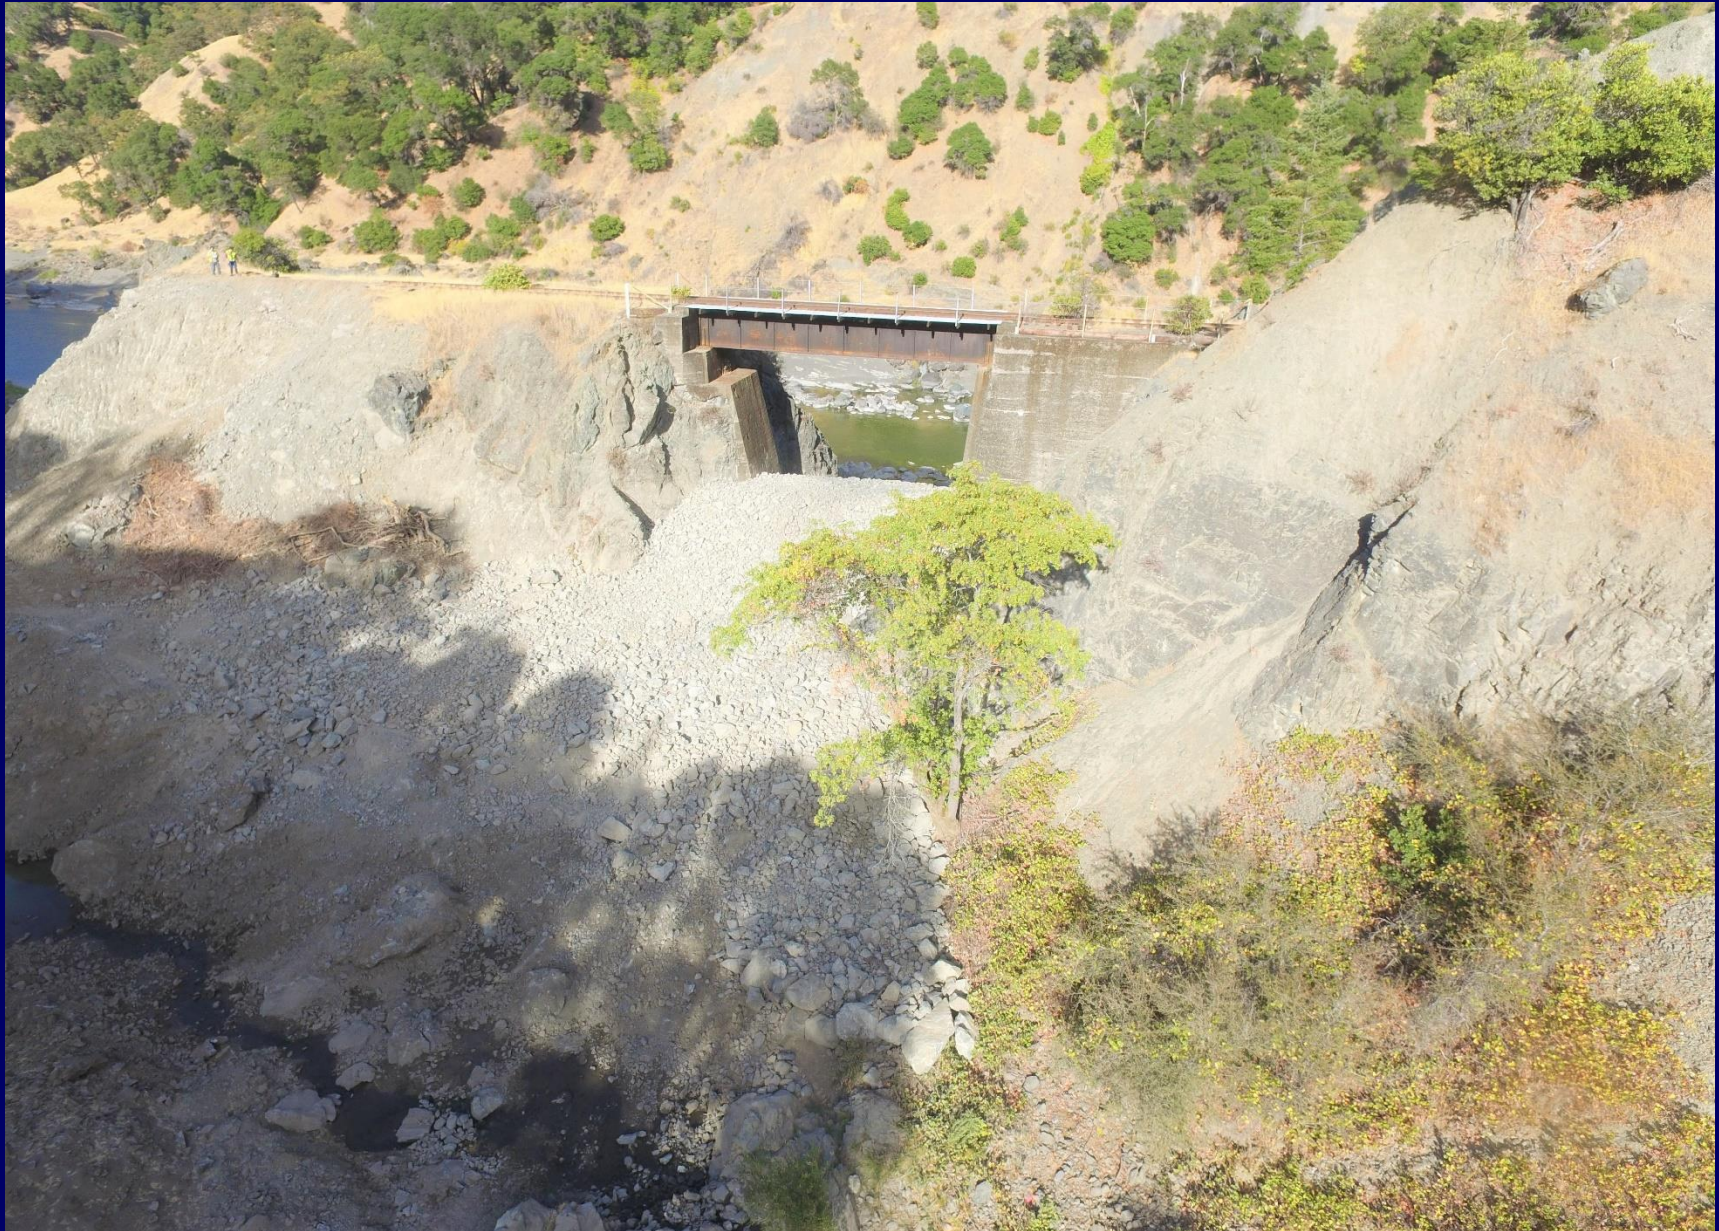
# The “Plugged” Bedrock Cut fom Woodman Creek
